AMTRAK WILMINGTON MAINTENANCE YARD 4001 VANDEVER AVENUE WILMINGTON, DELAWARE

Groundwater Elevation Hydrograph with LNAPL Thickness and Screened Interval

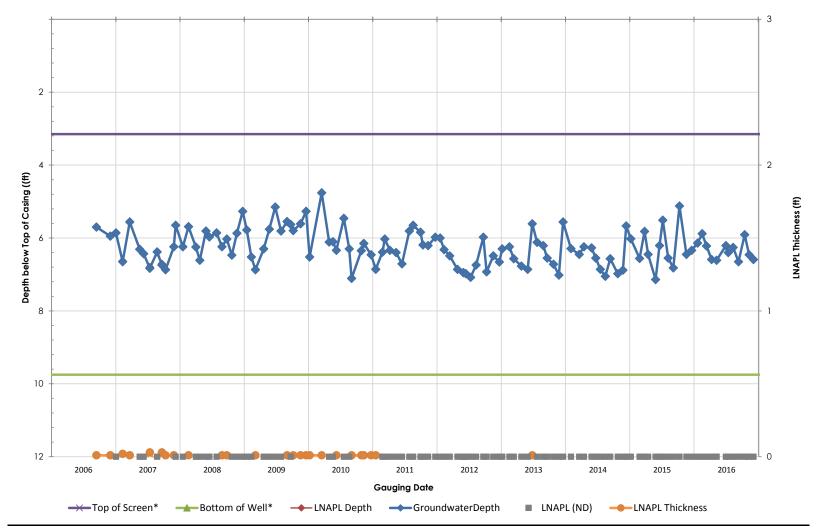
ED-5

Groundwater Elevation Hydrograph with LNAPL Thickness and Screened Interval

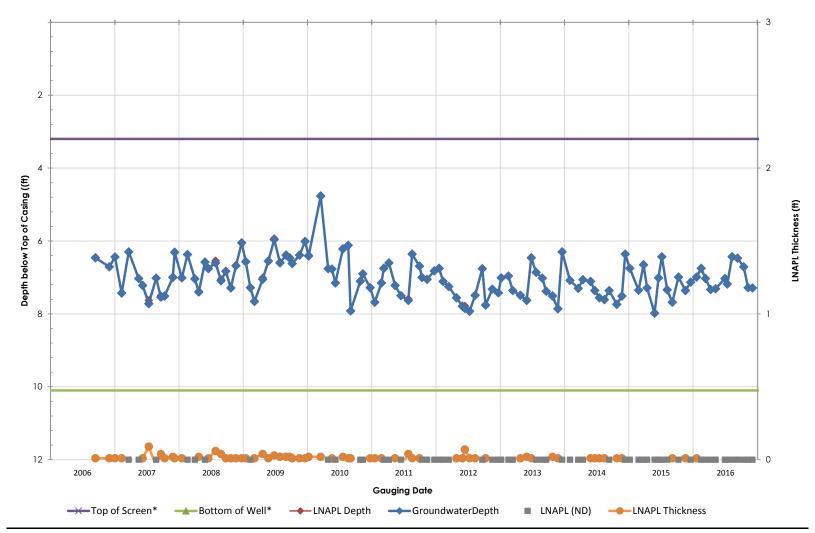
ED-6

Groundwater Elevation Hydrograph with LNAPL Thickness and Screened Interval

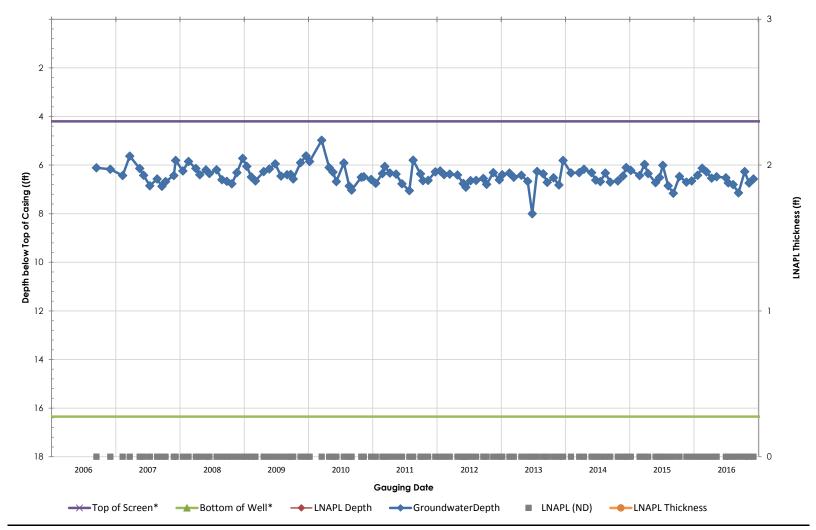
MW-1A

Groundwater Elevation Hydrograph with LNAPL Thickness and Screened Interval

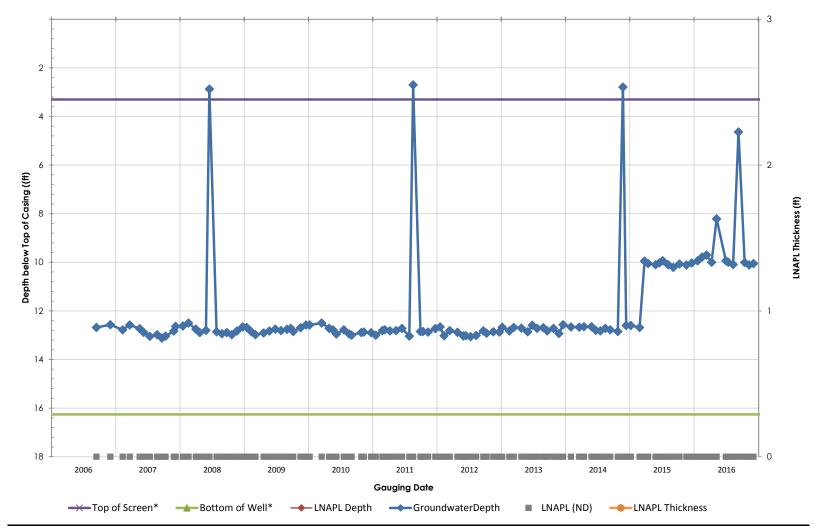
MW-3A

Groundwater Elevation Hydrograph with LNAPL Thickness and Screened Interval

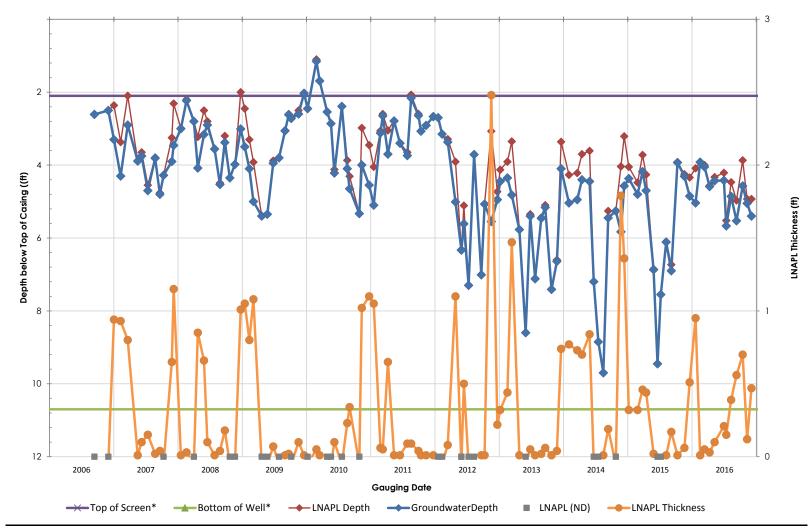
MW-5

Groundwater Elevation Hydrograph with LNAPL Thickness and Screened Interval

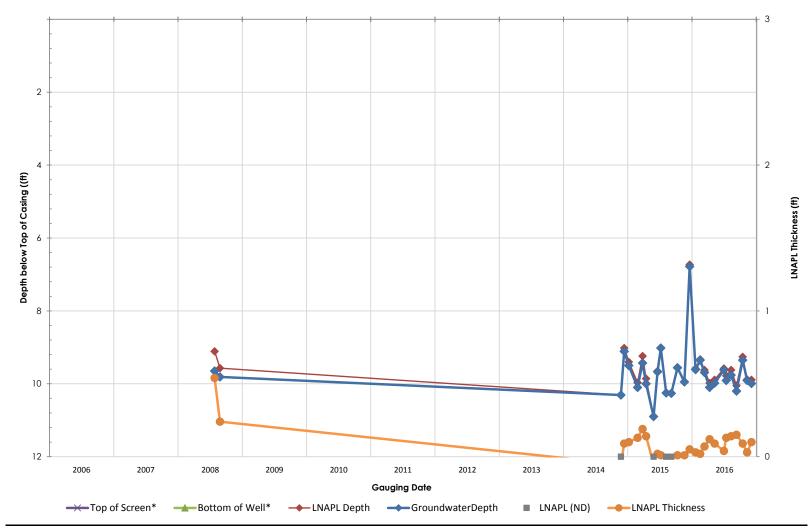
MW-6

Groundwater Elevation Hydrograph with LNAPL Thickness and Screened Interval

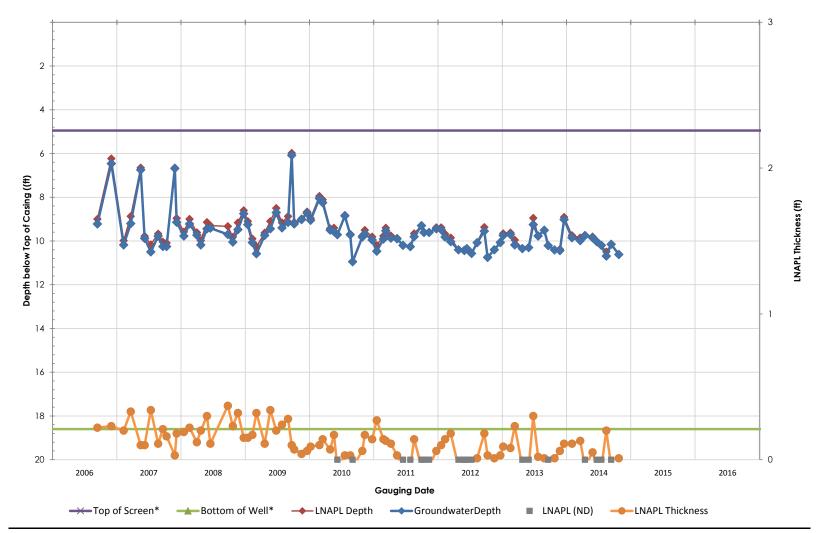
MW-6A

Groundwater Elevation Hydrograph with LNAPL Thickness and Screened Interval

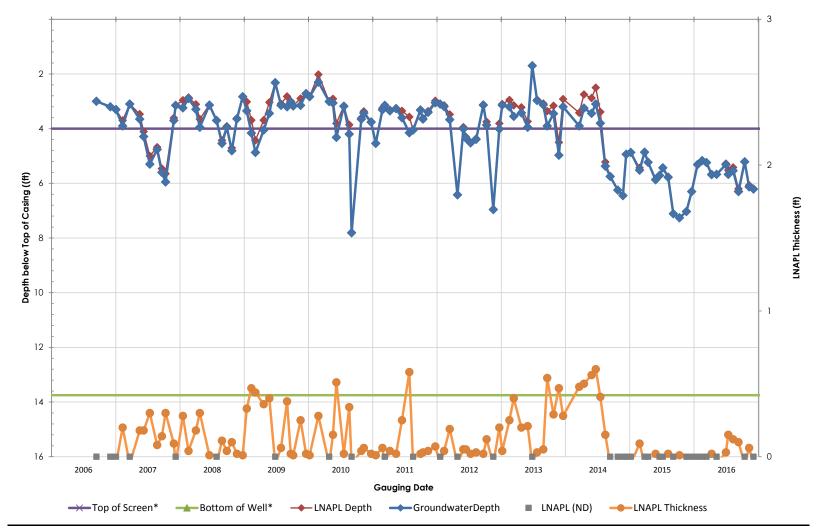
MW-7

Groundwater Elevation Hydrograph with LNAPL Thickness and Screened Interval

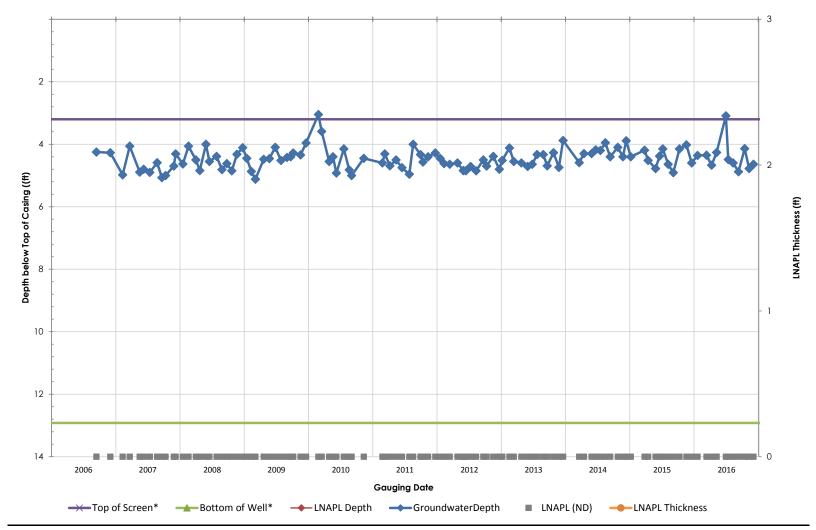
MW-8

Groundwater Elevation Hydrograph with LNAPL Thickness and Screened Interval

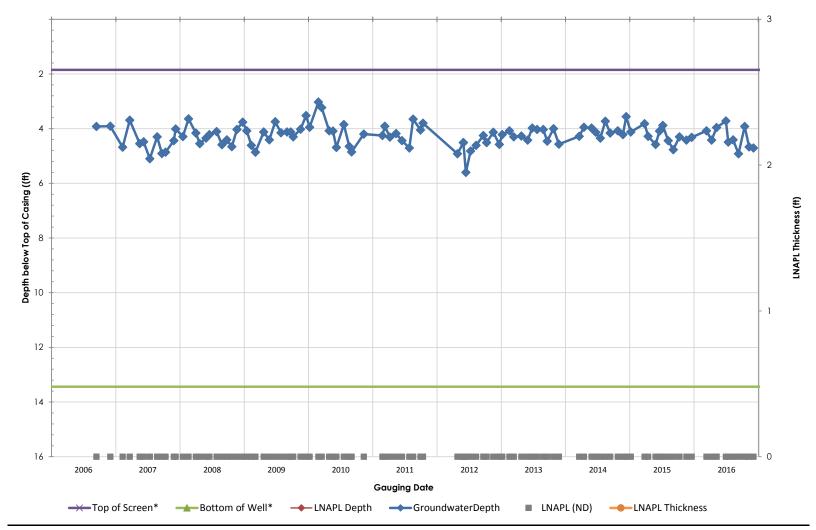
MW-8A

Groundwater Elevation Hydrograph with LNAPL Thickness and Screened Interval

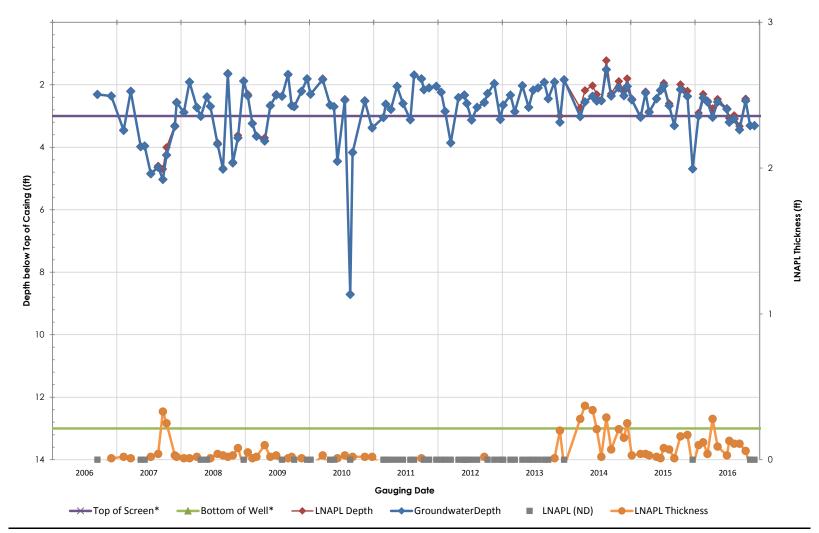
MW-9

Groundwater Elevation Hydrograph with LNAPL Thickness and Screened Interval

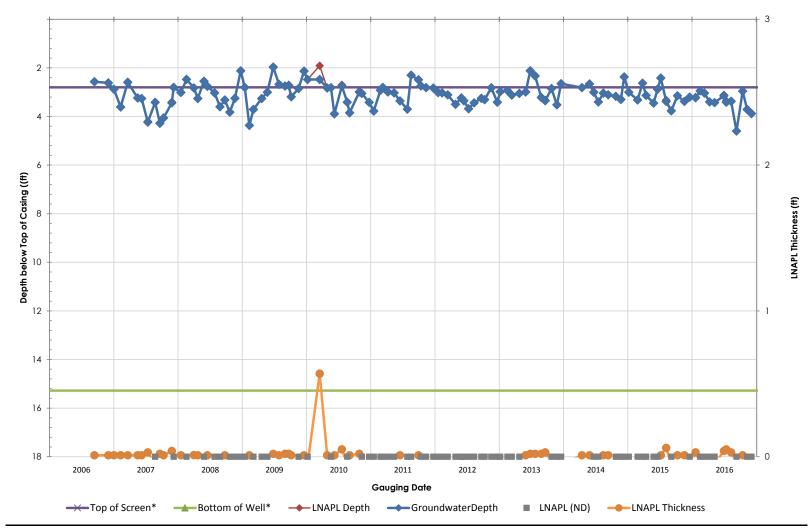
MW-10A

Groundwater Elevation Hydrograph with LNAPL Thickness and Screened Interval

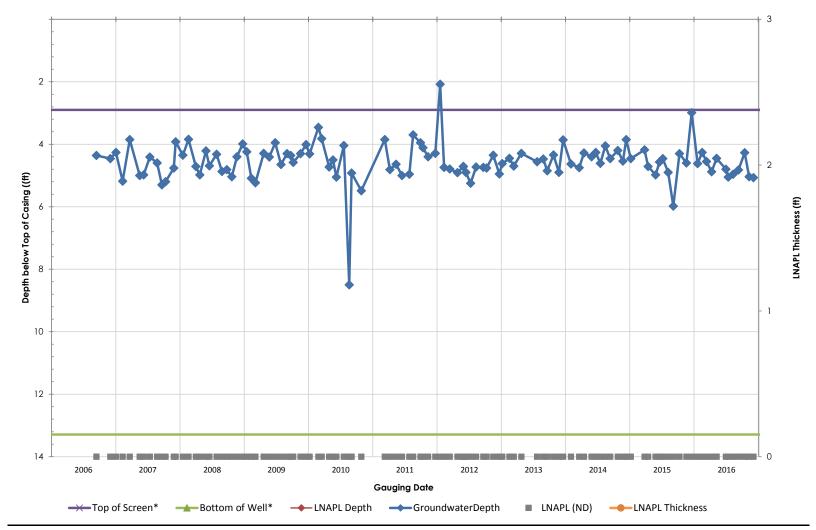
MW-14

Groundwater Elevation Hydrograph with LNAPL Thickness and Screened Interval

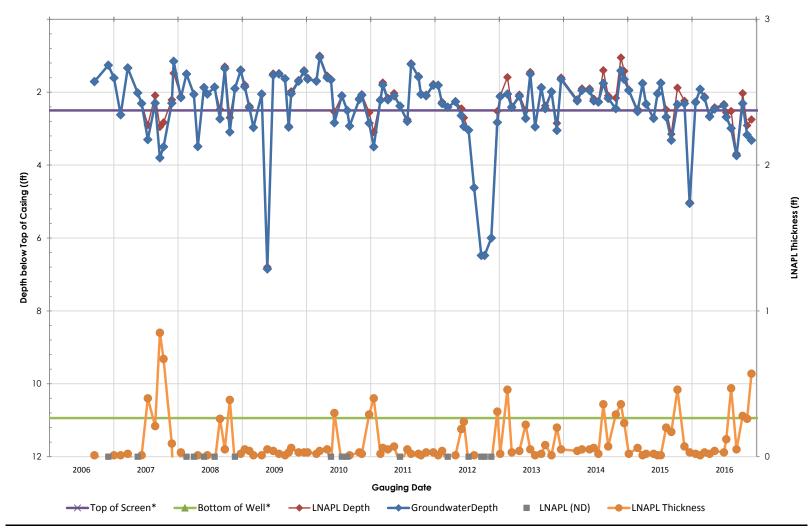
MW-15

Groundwater Elevation Hydrograph with LNAPL Thickness and Screened Interval

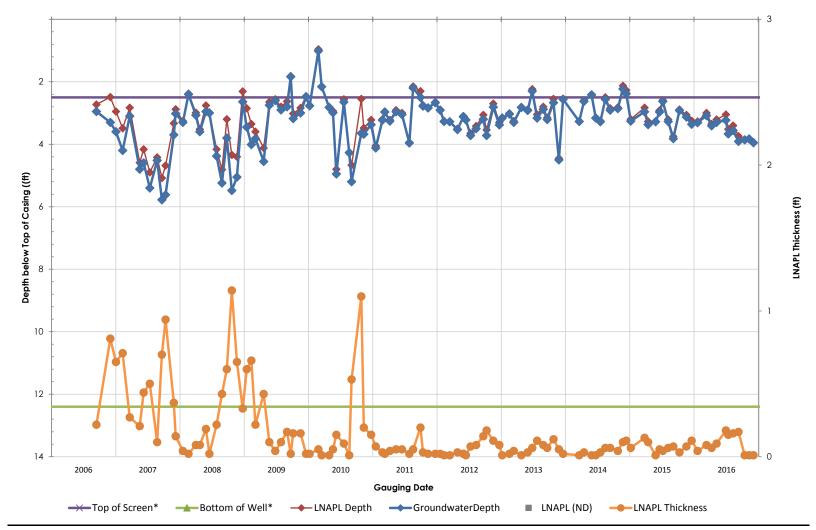
MW-16

Groundwater Elevation Hydrograph with LNAPL Thickness and Screened Interval

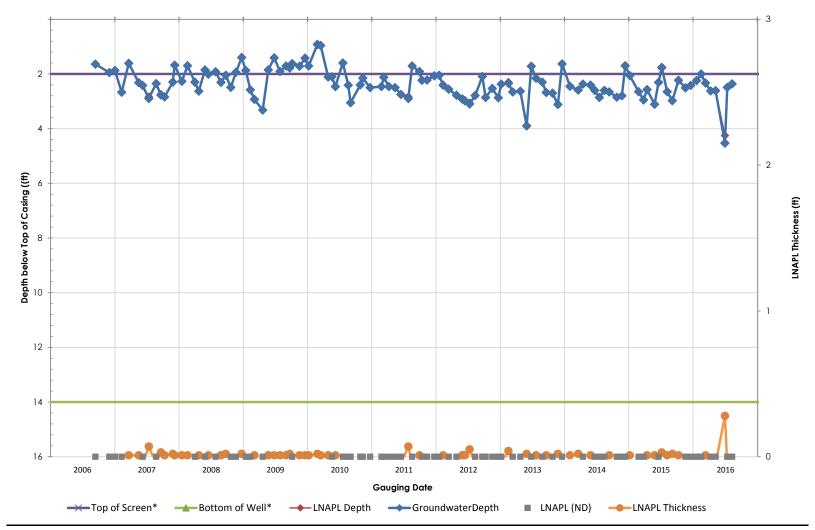
MW-17

Groundwater Elevation Hydrograph with LNAPL Thickness and Screened Interval

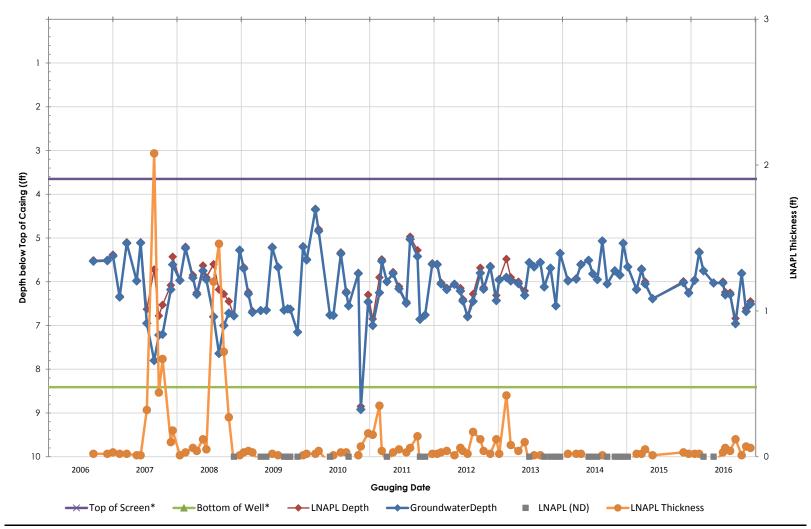
PZ-1

Groundwater Elevation Hydrograph with LNAPL Thickness and Screened Interval

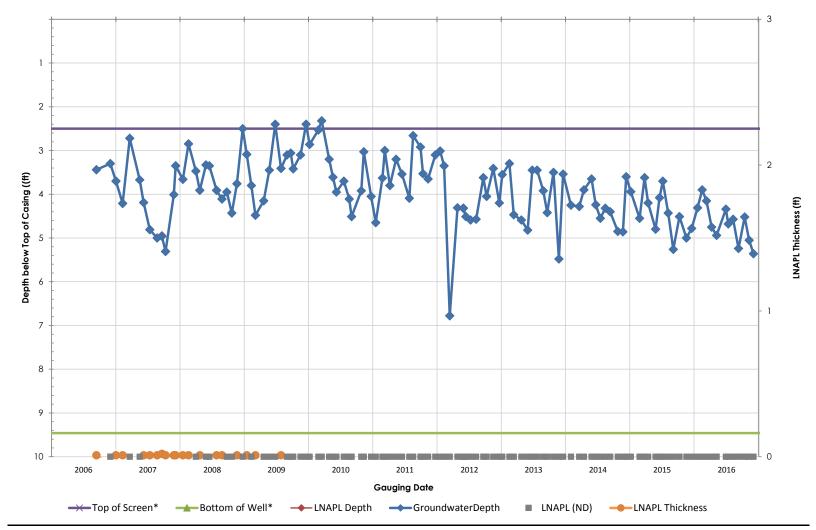
RW#3

Groundwater Elevation Hydrograph with LNAPL Thickness and Screened Interval

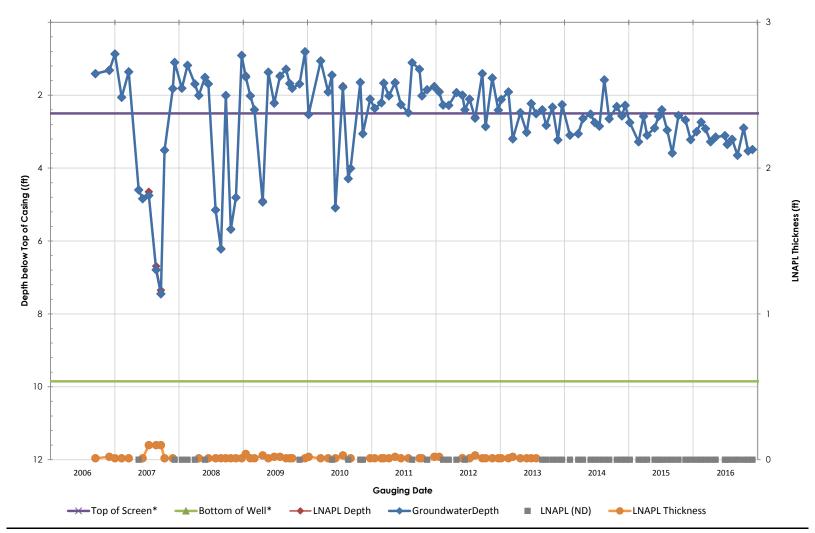
RW#4

Groundwater Elevation Hydrograph with LNAPL Thickness and Screened Interval

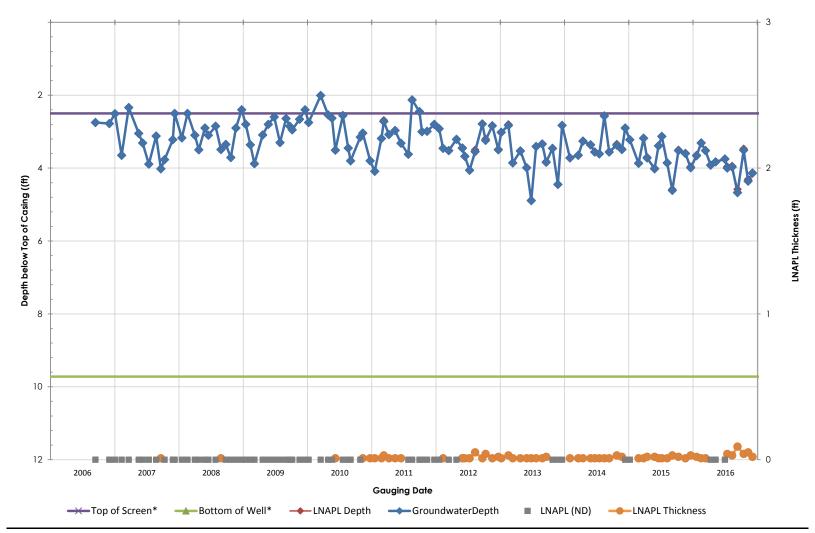
RW#5

Groundwater Elevation Hydrograph with LNAPL Thickness and Screened Interval

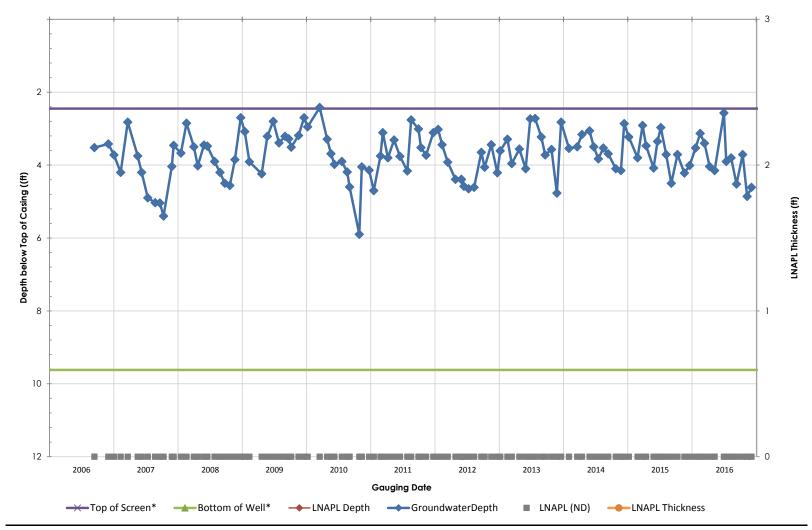
SP#1

Groundwater Elevation Hydrograph with LNAPL Thickness and Screened Interval

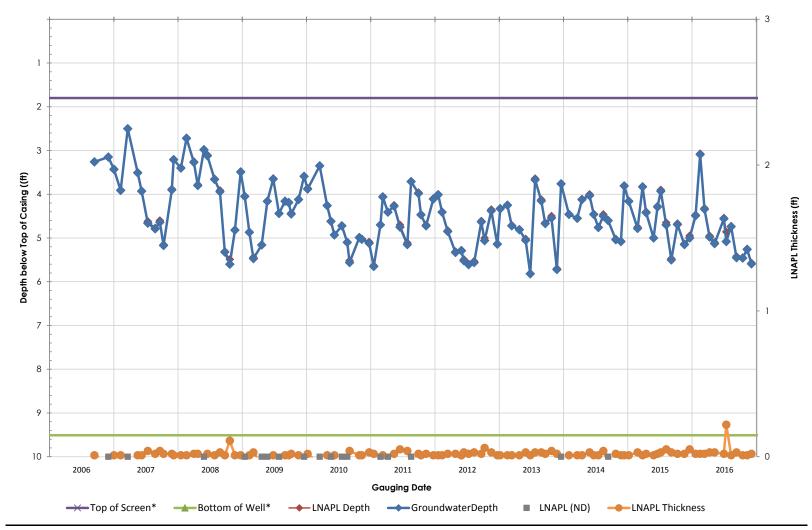
SP#2A

Groundwater Elevation Hydrograph with LNAPL Thickness and Screened Interval

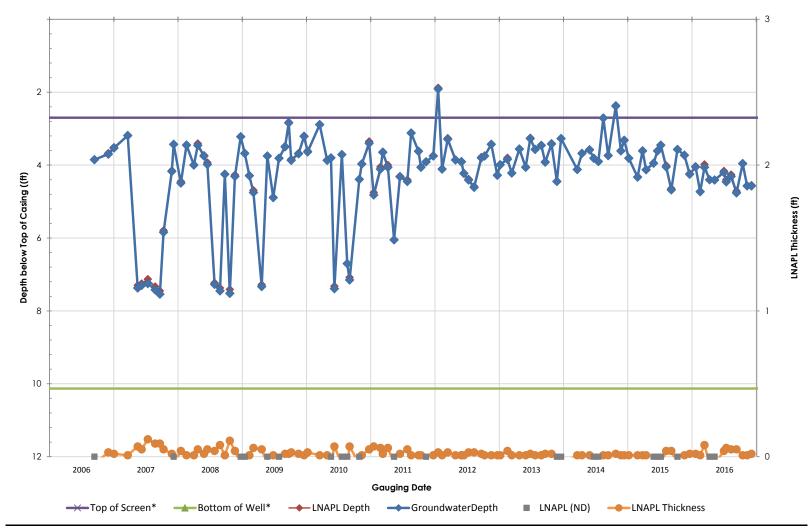
SP#4

Groundwater Elevation Hydrograph with LNAPL Thickness and Screened Interval

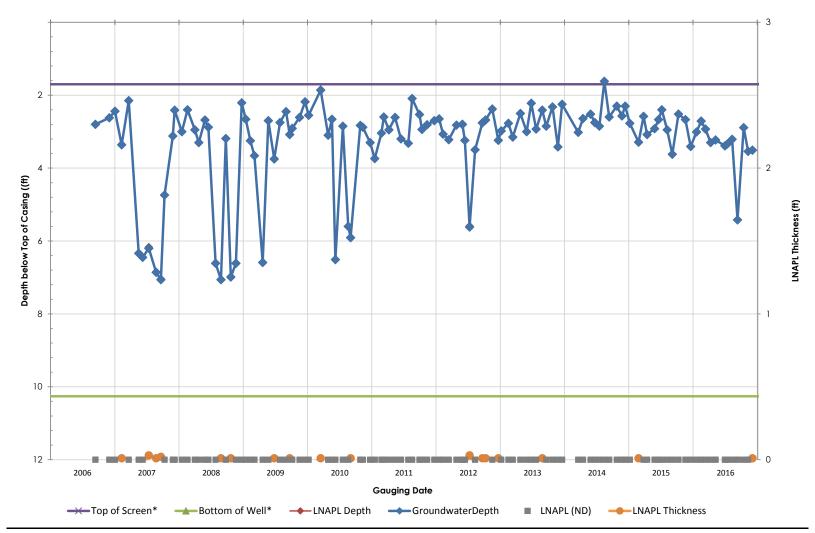
SP#5

Groundwater Elevation Hydrograph with LNAPL Thickness and Screened Interval

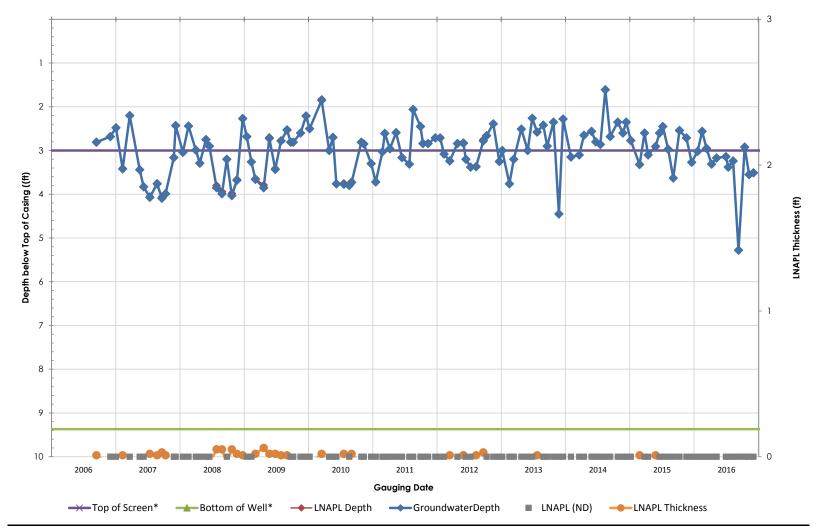
SP#6

Groundwater Elevation Hydrograph with LNAPL Thickness and Screened Interval

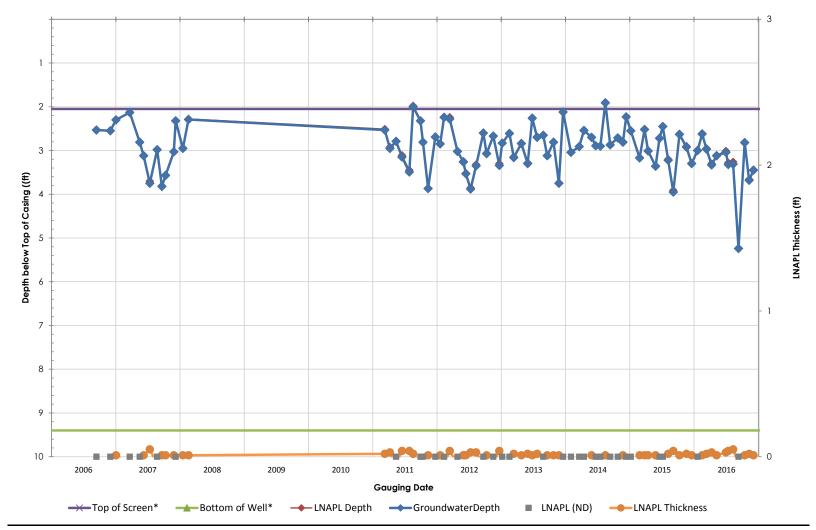
SP#8

Groundwater Elevation Hydrograph with LNAPL Thickness and Screened Interval

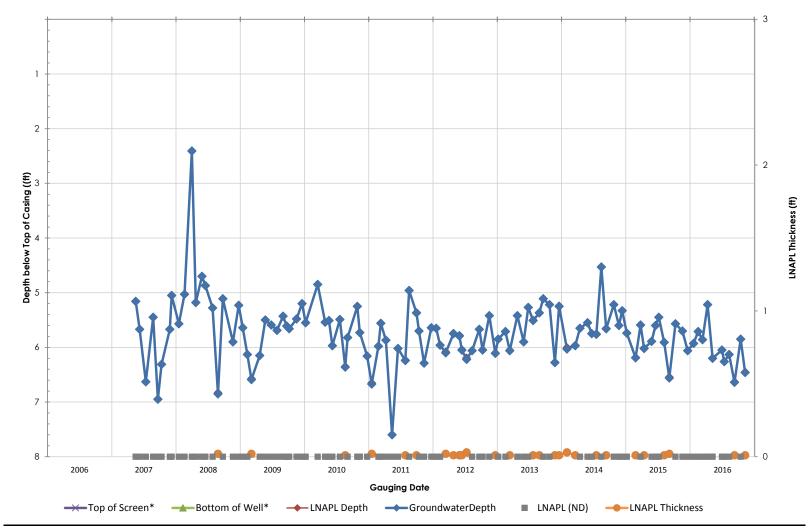
SP#10

Groundwater Elevation Hydrograph with LNAPL Thickness and Screened Interval

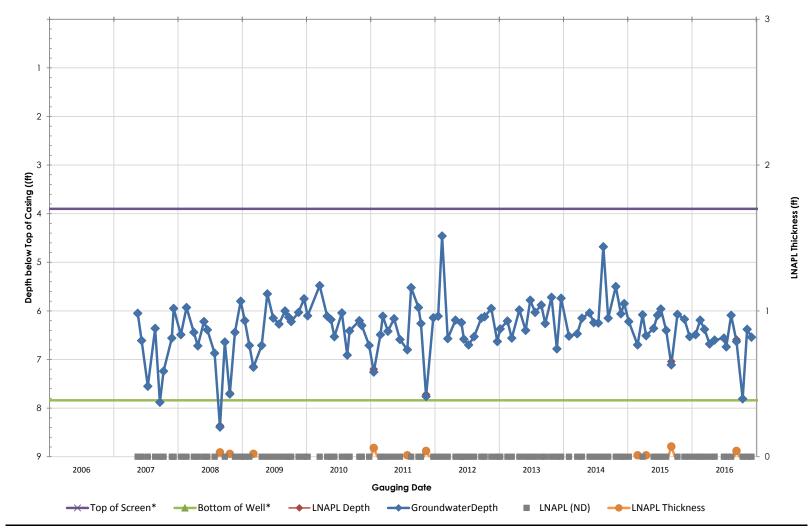
SP#11

Groundwater Elevation Hydrograph with LNAPL Thickness and Screened Interval

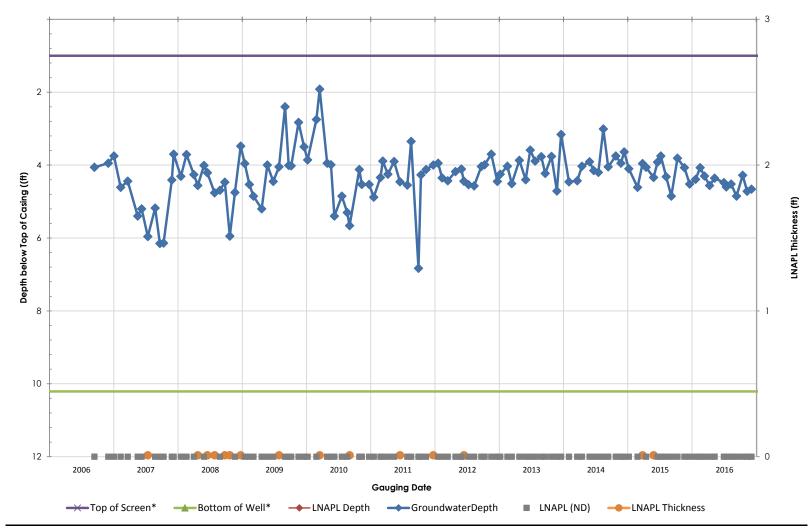
Sump#1

Groundwater Elevation Hydrograph with LNAPL Thickness and Screened Interval

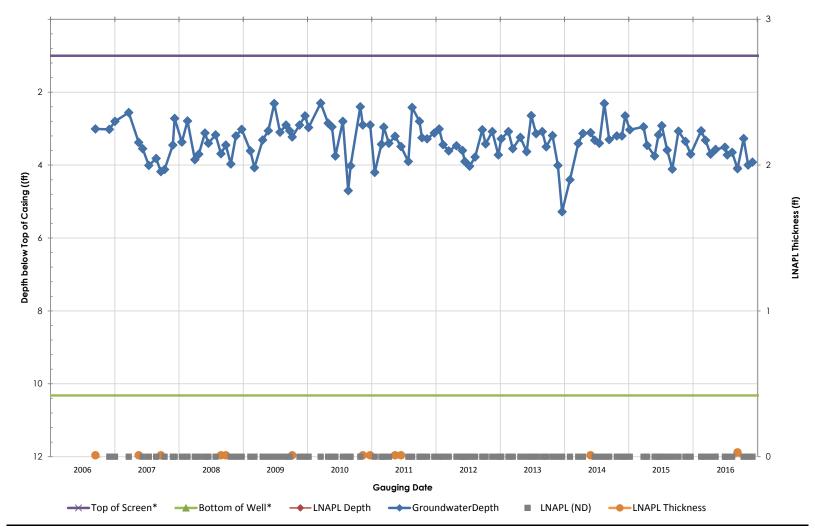
Sump#2

Groundwater Elevation Hydrograph with LNAPL Thickness and Screened Interval

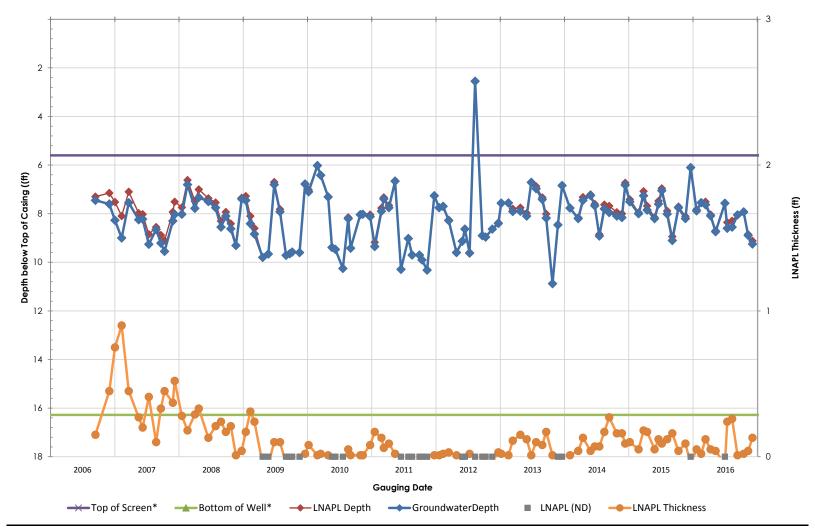
TP-1A

Groundwater Elevation Hydrograph with LNAPL Thickness and Screened Interval

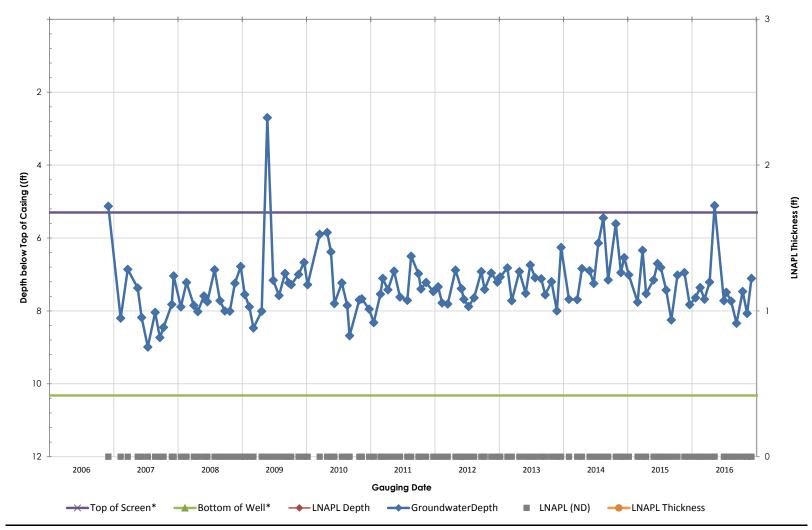
TP-7

Groundwater Elevation Hydrograph with LNAPL Thickness and Screened Interval

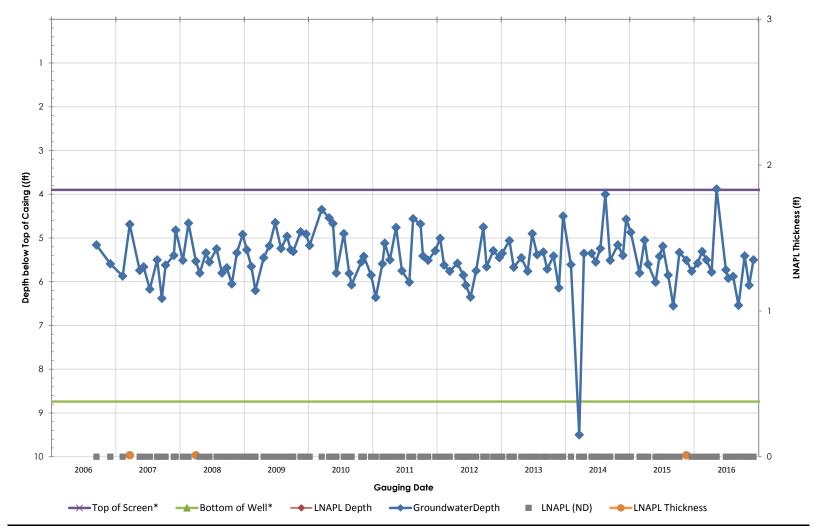
TP-9

Groundwater Elevation Hydrograph with LNAPL Thickness and Screened Interval

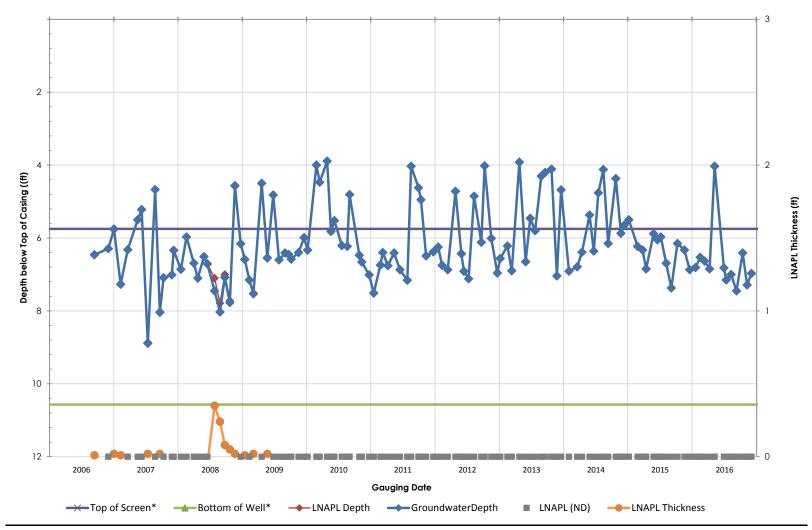
TP-101

Groundwater Elevation Hydrograph with LNAPL Thickness and Screened Interval

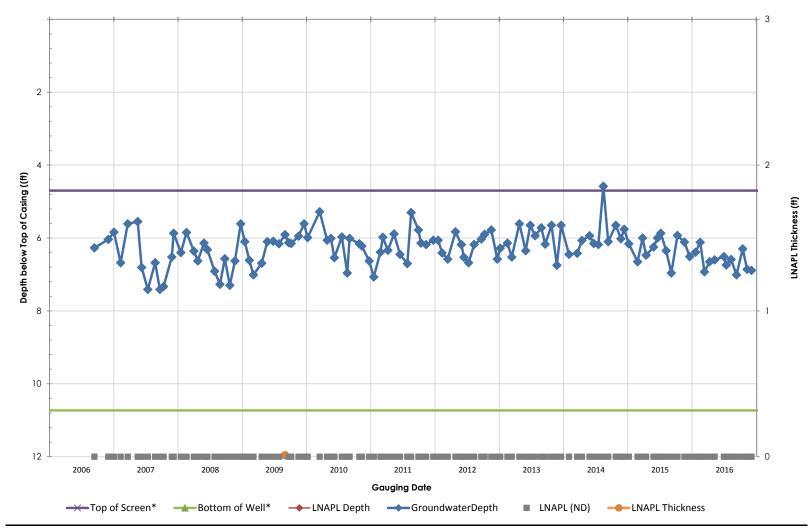
TP-103

Groundwater Elevation Hydrograph with LNAPL Thickness and Screened Interval

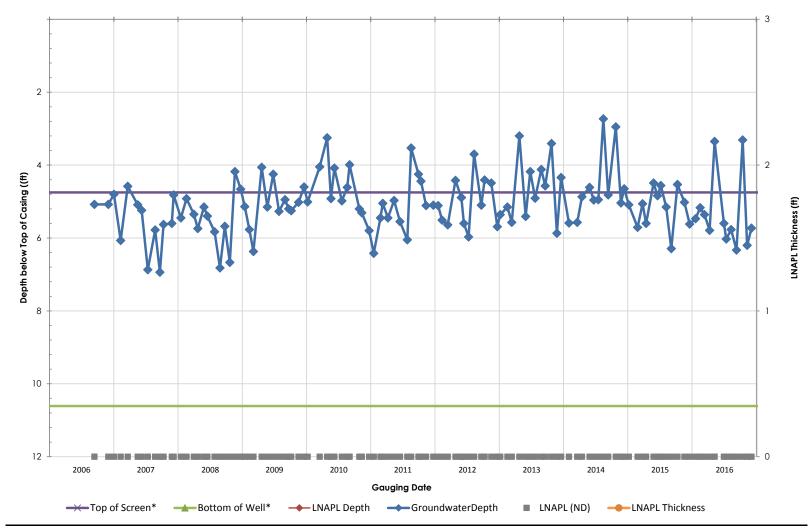
TP-104

Groundwater Elevation Hydrograph with LNAPL Thickness and Screened Interval

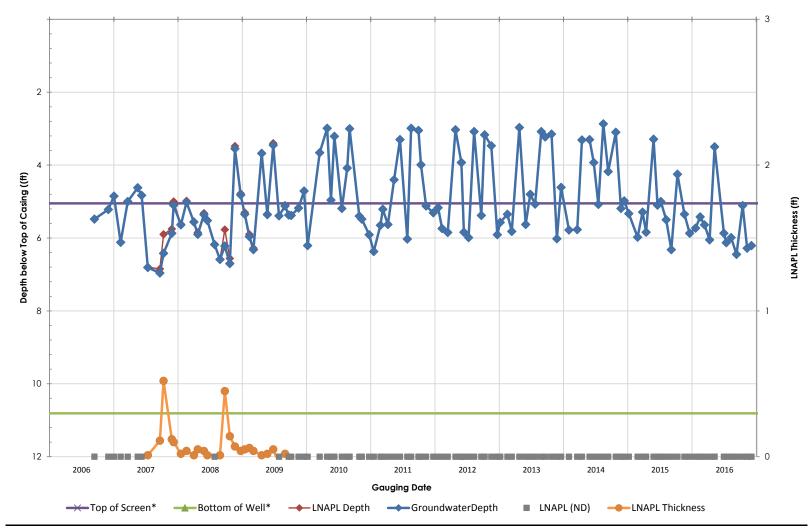
TP-105

Groundwater Elevation Hydrograph with LNAPL Thickness and Screened Interval

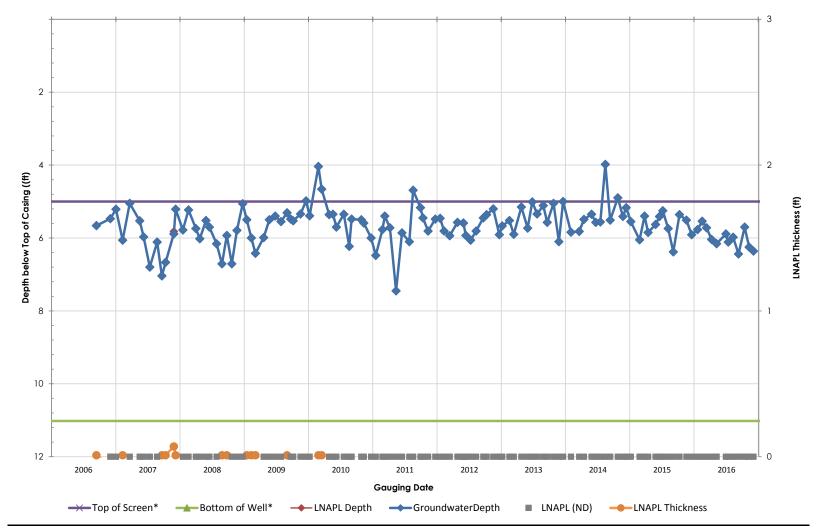
TP-106

Groundwater Elevation Hydrograph with LNAPL Thickness and Screened Interval

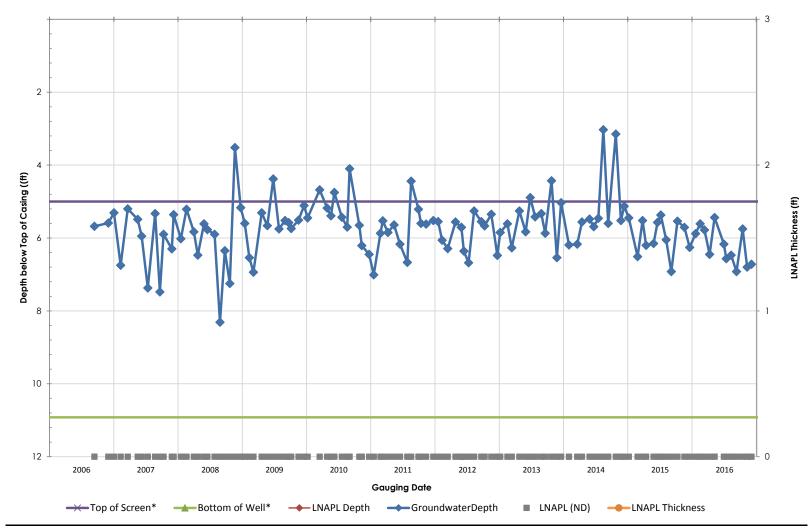
TP-109

Groundwater Elevation Hydrograph with LNAPL Thickness and Screened Interval

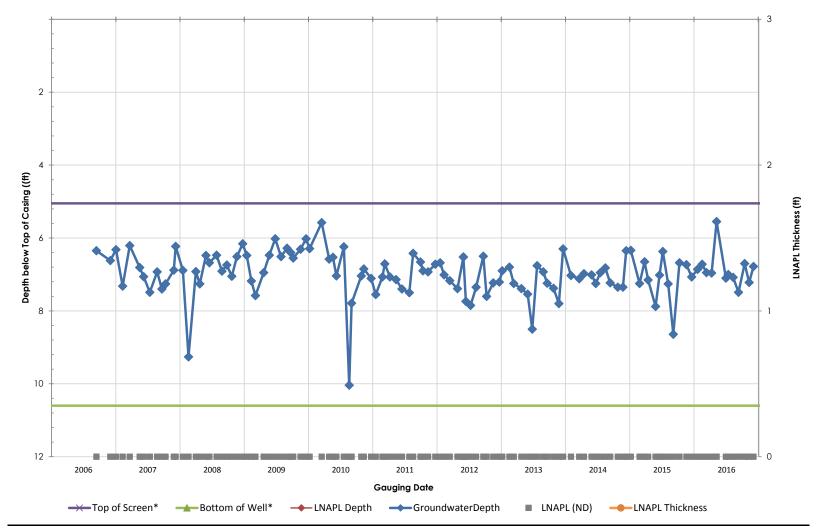
TP-110

Groundwater Elevation Hydrograph with LNAPL Thickness and Screened Interval

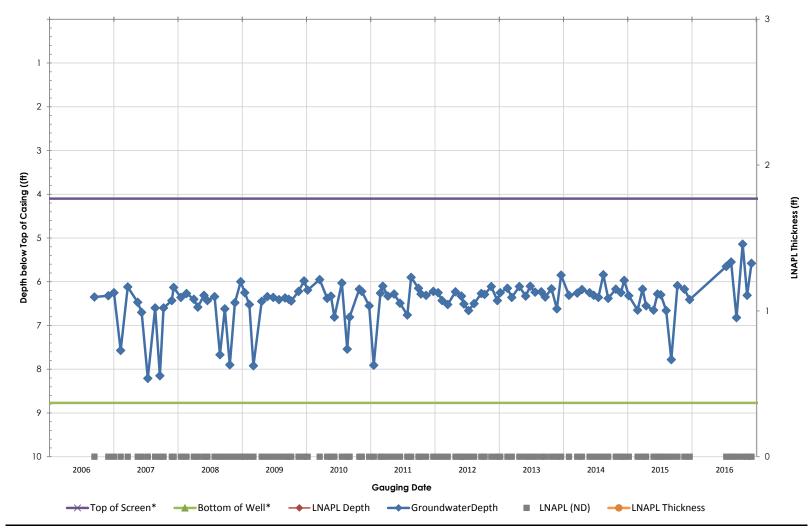
TP-113

Groundwater Elevation Hydrograph with LNAPL Thickness and Screened Interval

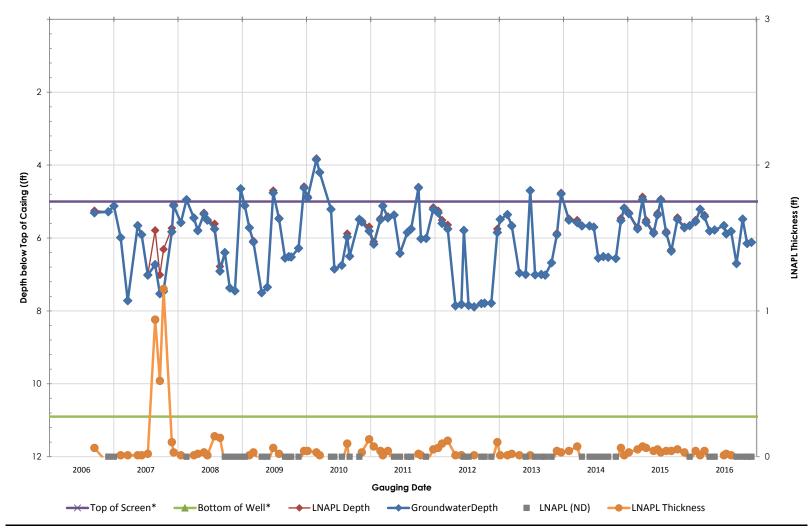
TP-114

Groundwater Elevation Hydrograph with LNAPL Thickness and Screened Interval

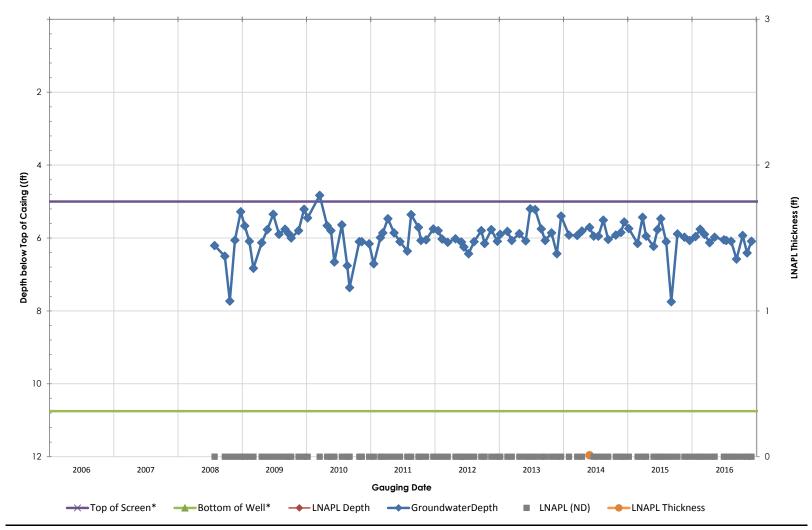
TP-115A

Groundwater Elevation Hydrograph with LNAPL Thickness and Screened Interval

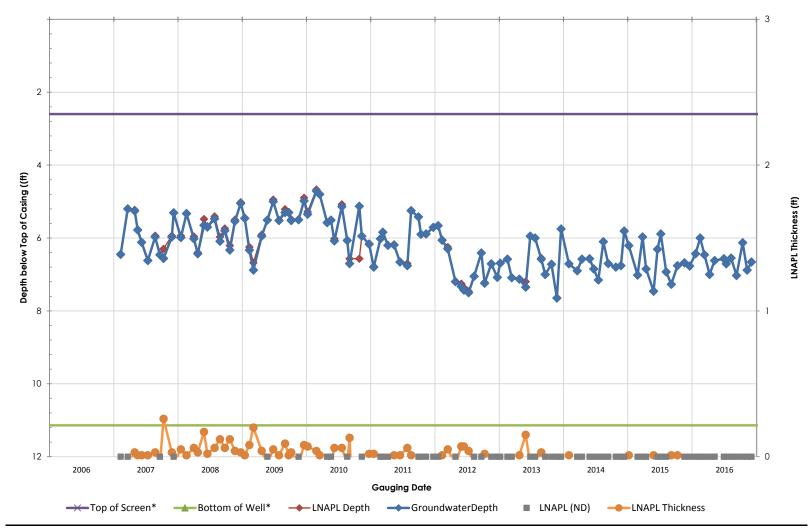
TP-117

Groundwater Elevation Hydrograph with LNAPL Thickness and Screened Interval

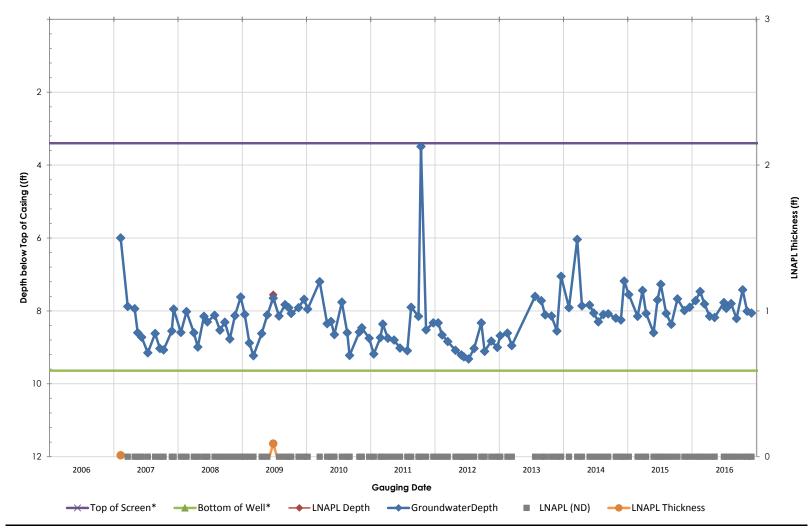
TP-119

Groundwater Elevation Hydrograph with LNAPL Thickness and Screened Interval

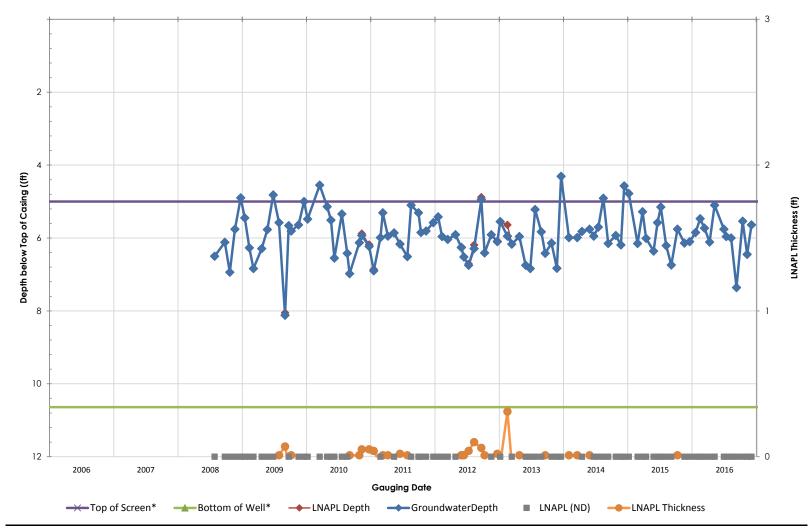
TP-121A

Groundwater Elevation Hydrograph with LNAPL Thickness and Screened Interval

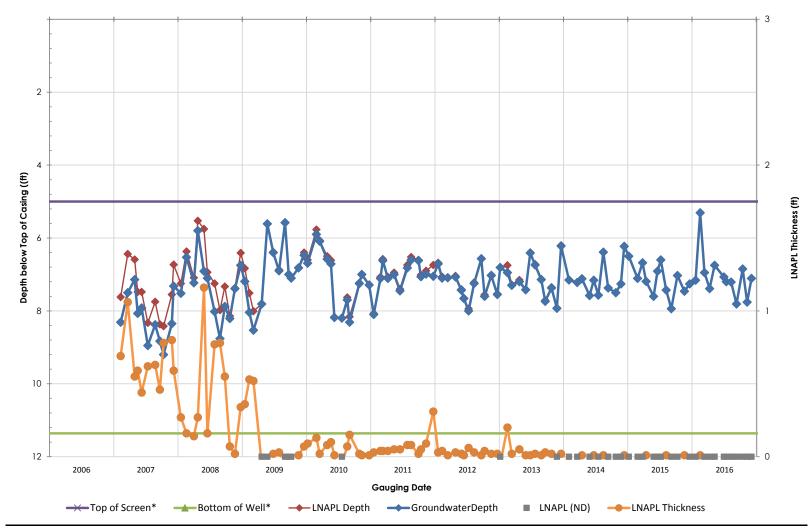
TP-122

Groundwater Elevation Hydrograph with LNAPL Thickness and Screened Interval

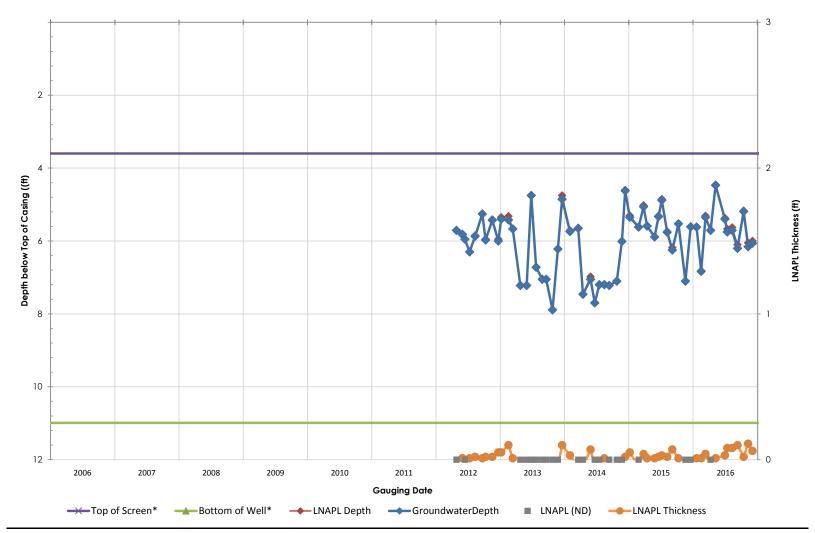
TP-122A

Groundwater Elevation Hydrograph with LNAPL Thickness and Screened Interval

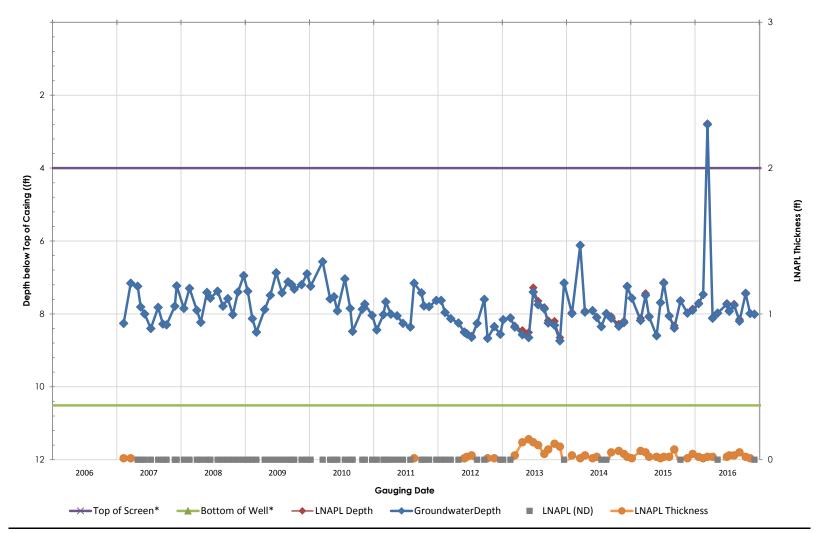
TP-124

Groundwater Elevation Hydrograph with LNAPL Thickness and Screened Interval
